Chair and Department of Jaw Orthopedics, 2<sup>nd</sup> Department of Radiology  
Medical University of Lublin

EWA KROCHMALSKA, WITOLD KRUPSKI

*Use of spiral computed tomography in the assessment  
of diagnostically difficult impacted teeth*

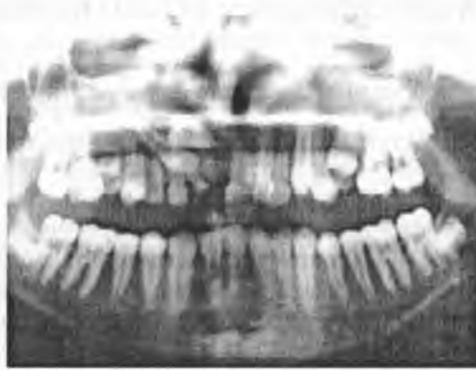
Fig. 1A. Visible in the panoramic x-ray in the right half of the maxilla, an impacted canine and central incisor, a hypoplastic lateral incisor, a missing bud of the second premolar and a supernumerary tooth in the vicinity of the left lateral incisor

Case 1. The panoramic dental x-ray of a patient aged 12.4 years revealed in the right half of the maxilla two impacted teeth (the canine and the central incisor), hypoplasia of the lateral incisor, and agenesis of the second premolar. On the left in the region of the lateral incisor there was a supernumerary tooth (Fig. 1A). In order to localize impacted teeth more precisely spiral CT scanning was performed. The 3-dimensional picture accurately presented the relationships between impacted teeth and adjacent structures and, what is more, showed dilacerations in half the root of the central incisor, which was not to be seen in the panoramic radiograph (Fig. 1B).

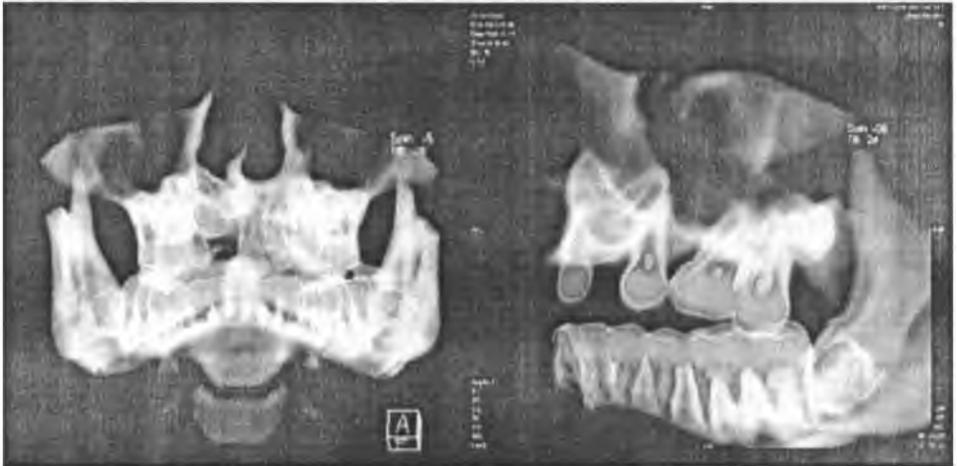
Fig. 1B. The 3D VRT (volume reconstruction technique) image showed a dilaceration of the right central incisor and determined the relationships of impacted teeth with each other and with neighbouring structures

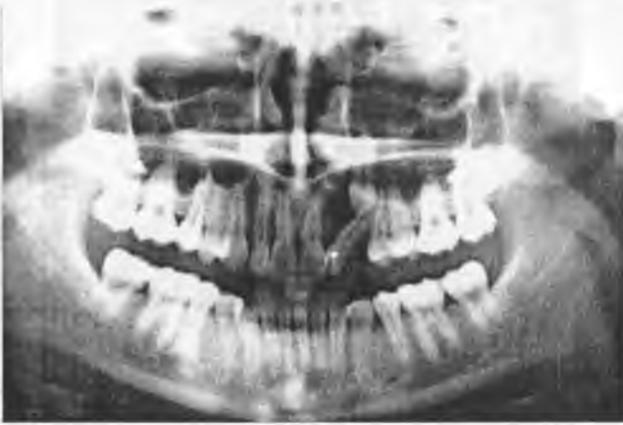
Fig. 2A. Visible in the panoramic x-ray an impacted upper left canine and a cyst in the region of the left lateral incisor and impacted canine

Case 2. Patient aged 14.9 presented with a horizontally placed upper left lateral incisor and a lack of left upper canine. A panoramic x-ray was performed which revealed high on the left in the maxilla an impacted canine and a follicular cyst nearby (Fig. 2A). The CT scan confirmed the presence of the cyst, made clear the position of neighbouring teeth in relation to the cyst and allowed

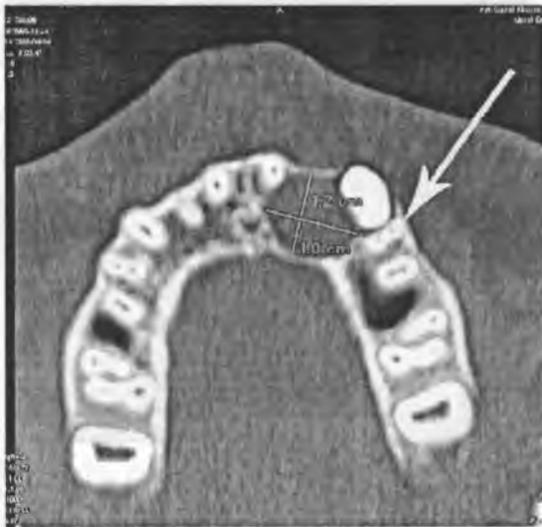
Fig. 2B. An axial CT scan of the upper left canine reveals a follicular cyst sized 1.0 by 1.2 mm and resorption of the upper left first premolar

for the assessment of its size (1.0–1.2 cm). Axial scans of the spiral CT revealed resorption of the mesial wall of the first left premolar adjacent to the impacted canine. The resorption involved cementum and a part of radical dentine (Fig. 2B, C, D).

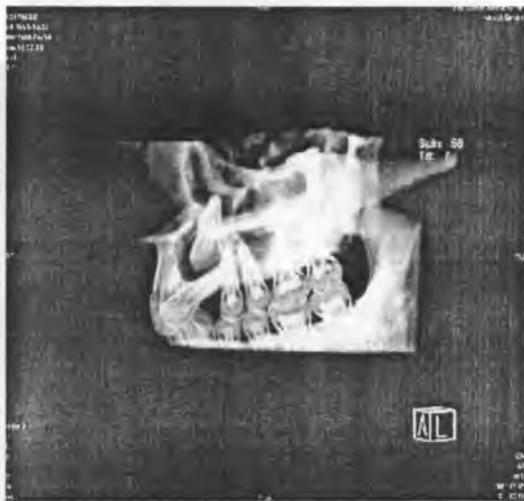
Fig. 2D. Visible in the 3D VRT image location of adjacent teeth in relation to the cyst

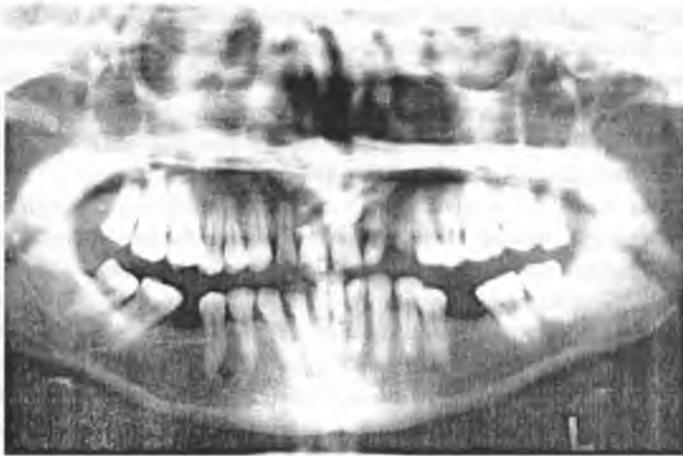
Fig. 3A. Visible in the panoramic x-ray in the maxilla on the left, an impacted canine, a persisting deciduous canine and a hypoplastic lateral incisor

Case 3. The clinical examination of patient aged 30.2 years demonstrated malocclusion in the form of overbite, a diminished-in-size upper/lower left lateral incisor and absence of upper left canine and two lower first molars. The panoramic radiograph showed the impacted upper left canine, which overlapped the left lateral and central incisors. The top of the crown of the impacted canine reached the median line of the maxilla (Fig. 3A). CT scans revealed resorption of the lateral incisor root, with a thin sheet of radical dentine left, and severe (reaching the pulp) resorption of central incisor root (Fig. 3B).
